Inspection Report

777 Sample Street
San Diego 92120

SOLID FOUNDATION

Home Inspection Service

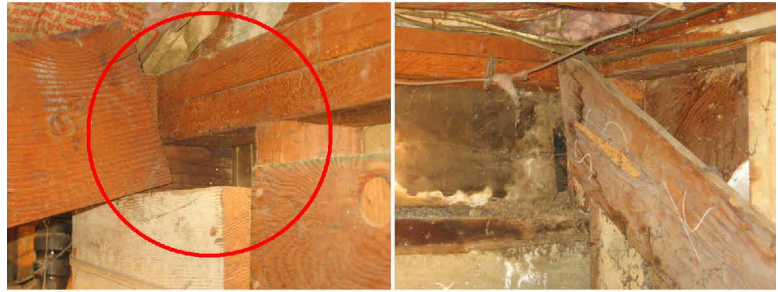
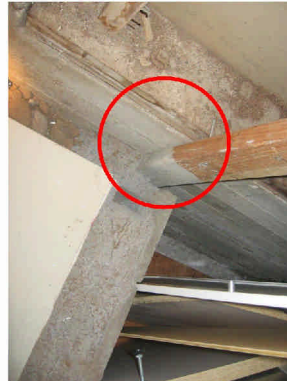
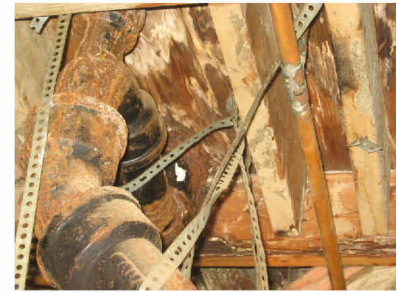
107 FRAMING

[FE] The wood framing lacked adequate separation from the soil. The girder support beam(s) lacked proper support on the sill plate and were over notched.

[FE] Moisture stains/damage were noted at several locations. We recommend a full evaluation and/or correction(s) by an appropriate professional in the appropriate trade - a qualified licensed contractor specializing in moisture detection/intrusion. Also consult with the seller for additional disclosures of any past condition(s).

Improper framing practices noted. We recommend a full evaluation and/or correction(s) by an appropriate professional in the appropriate trade - a qualified licensed contractor specializing in foundation/floor framing systems.

[RU] Piers, posts, beams and general framing was toe nailed together. This is older technology. We recommend upgrading to incorporate approved metal brackets and connectors in the foundation system to perform better during seismic activity. This should be done by a qualified licensed contractor specializing in foundation seismic retrofit.

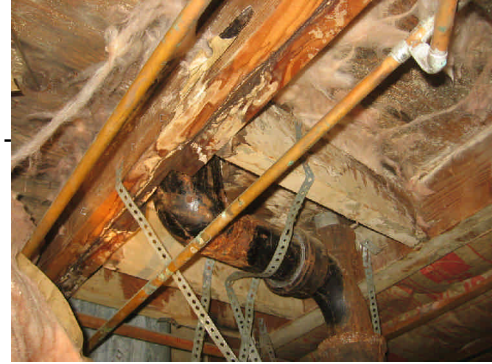
112 SUBFLOOR

[FE] Moisture stains/damage were noted at several locations. We recommend a full evaluation and/or correction(s) by an appropriate professional in the appropriate trade - a qualified licensed contractor specializing in moisture detection/intrusion. Also consult with the seller for additional disclosures of any past condition(s).

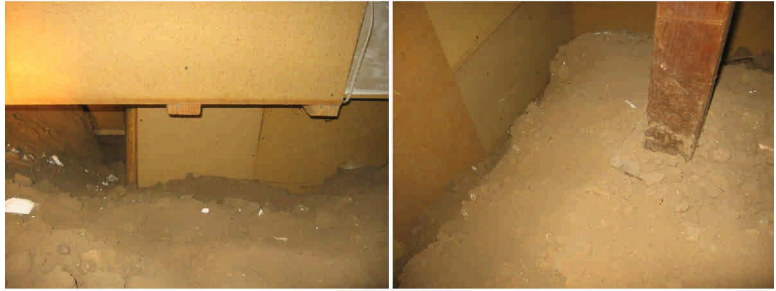
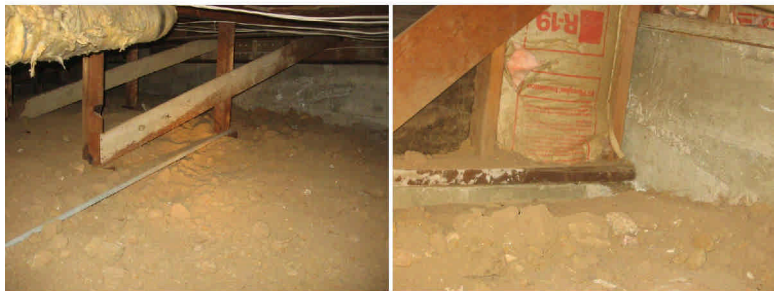
119 SEPARATION

[FE] The wood framing lacked adequate separation from the soil at multiple areas. We recommend a full evaluation and/or correction(s) by an appropriate professional in the appropriate trade - a qualified licensed contractor specializing in foundation/floor framing systems.

[FE] There was evidence of conditions that require further evaluation by a pest control operator. The independent structural pest inspection report should be reviewed for additional information.

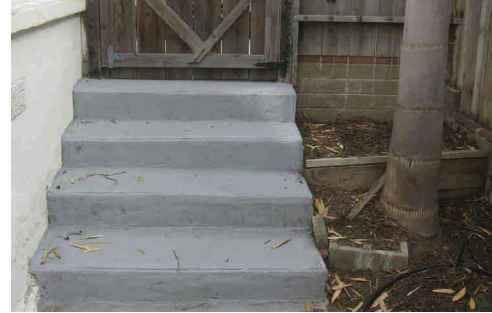
220 STEP(S)/STAIR(S)

[SC] There was no handrail on the stairs. This is a safety concern. We recommend correcting the condition(s) noted.

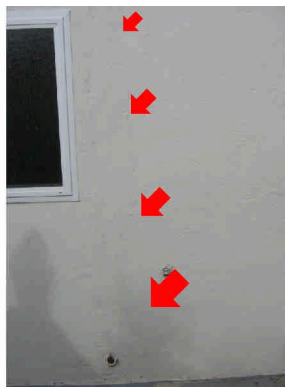
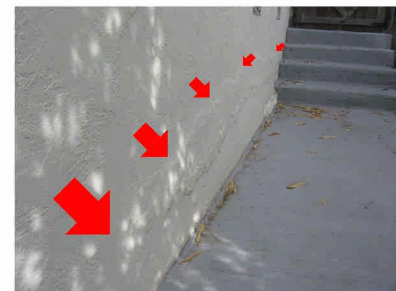
238 STUCCO CLADDING

The stucco siding appeared functional, with cracks noted, with exceptions noted.

[FE] The stucco siding was noted as having past repairs. We recommend inquiring about the condition(s) noted.

[CR] This building was built in an era before weep screeds were installed at the bottom edge of the stucco siding, the stucco was extended into the soil or grade. The stucco wicks water up out of the soil. We recommend minimizing moisture around the building to help protect the stucco and the foundation from moisture damage.

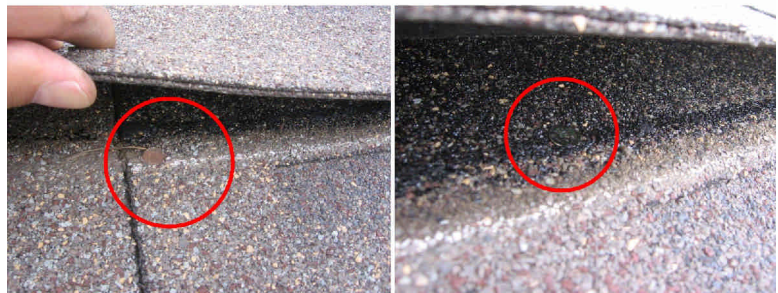
306 COMP. SHINGLES

[CR] Nail(s) too close to the edge of the shingle(s). We recommend correcting the condition(s) noted.

[CR] Nail(s) driven into the self-sealing strip. Nails are required to be driven just below the sealing strip, not in it. We recommend correcting the condition(s) noted.

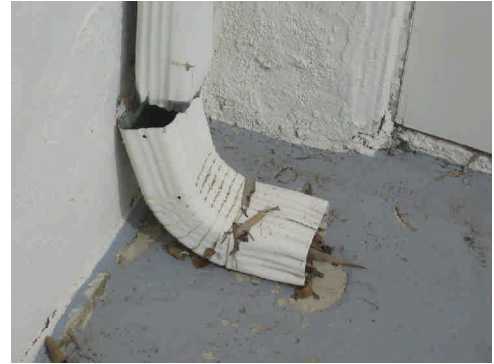
[CR] There were damaged and missing downspout(s). We recommend correcting the condition(s) noted.

[CR] Runoff water from the roof discharged next to the building. We recommend the downspouts be routed sufficiently away from the building to prevent ponding, pooling, and saturation of the soil at the foundation.

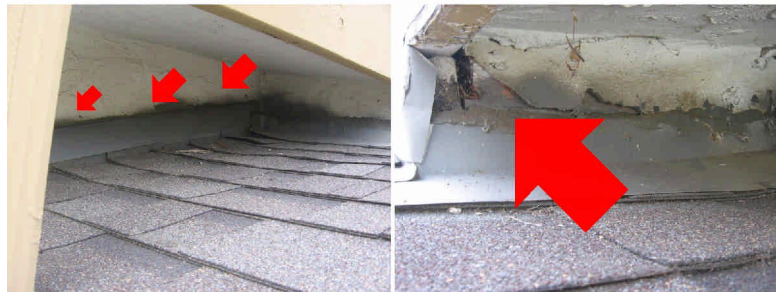
320 FLASHING(S)

[FE] Face nailing of the flashings was noted. This condition is conducive to moisture intrusion and rusting of nail heads. We recommend a full evaluation and/or corrections by an appropriate professional in the appropriate trade.

[FE] The side wall flashing was caulked to the siding. This is an improper installation of the flashing. We recommend a full evaluation and/or correction(s) by an appropriate professional in the appropriate trade.

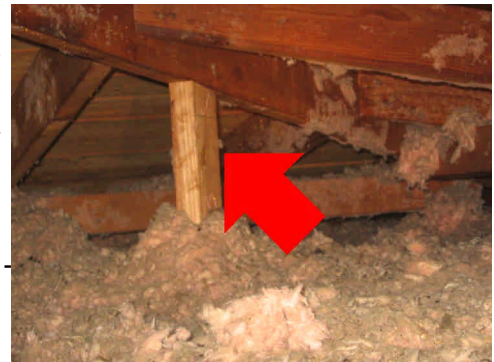
[FE] Past repairs/structural securing/reinforcement noted. We recommend a full evaluation and/or correction(s) by an appropriate professional in the appropriate trade - a qualified contractor specializing in attic structural framing.

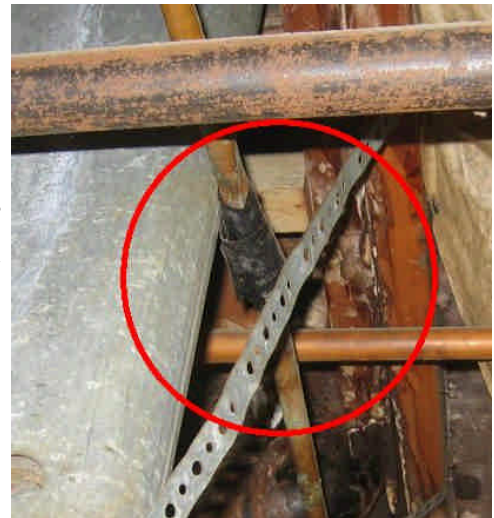
| 507 WATER PIPING | <p>[CR] There was corrosion noted in the crawlspace area. We recommend correcting the condition(s) noted.</p> <p>[CR] Copper and dissimilar metal were in contact with each other. This condition can lead to corrosion/electrolysis between these dissimilar metals. We recommend correcting the condition(s) noted.</p> <p>[CR] There were un-insulated water supply pipes. All exposed water supply pipes, hot or cold should be insulated to help minimize heat loose.</p> |

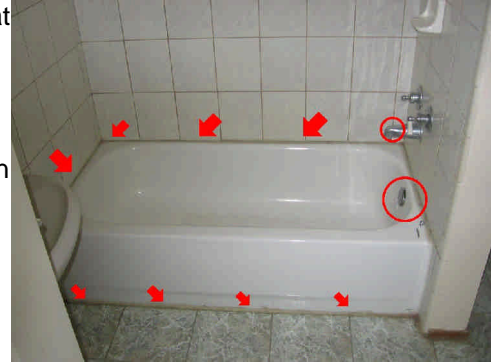
518 TUB(S)/SHOWER(S)

[FE] Excessive caulking was noted at areas within the tub/shower area. This may indicate leakage into conceal spaces behind the tub/shower walls. Moisture causes damage to subsurface areas and can lead to bio-organic growth within the walls. We recommend a full evaluation by a qualified contractor specializing in bathroom shower/tub moisture intrusion/investigation and remediation.

[CR] The tub overflow drain cover was upside-down, this condition is a potential leak if the tub is filled to this level. We recommend correcting the condition(s) noted.

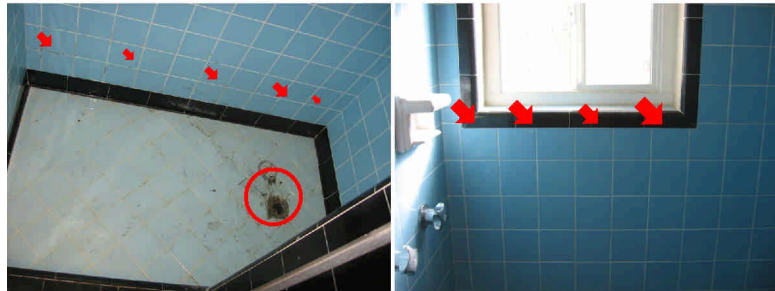
520 SHOWER(S)

[FE] The grout/caulking was cracked and/or missing. Darker/discolored row of tiles noted at bottom of wall(s) and hollow tiles noted. This is conducive to moisture intrusion/damage into subsurface concealed areas such as the walls/floors. We recommend a full evaluation by a qualified contractor specializing in bathroom shower/tub moisture intrusion/investigation and remediation.

[FE] Hollow and/or loose tile assembly at window sill noted. This is indicative of water intrusion into the area. We recommend a full evaluation and/or correction(s) by an appropriate professional in the appropriate trade.

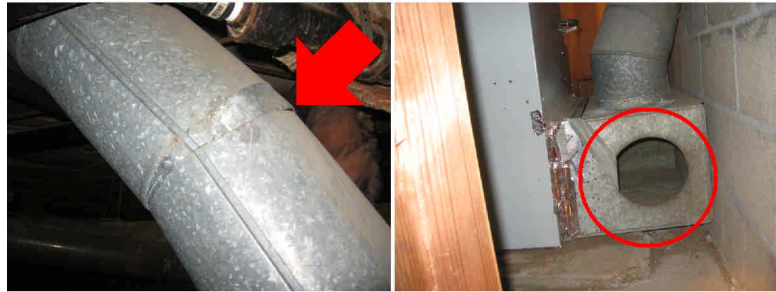
712 RETURN PLENUM(S)

[CR] The return air plenum was dirty. We recommend cleaning this area of all dirt and/or debris.

[CR] The duct was disconnected and the plenum had a large hole in it and air from the crawlspace was entering into the return plenum. We recommend correcting the condition(s) noted.

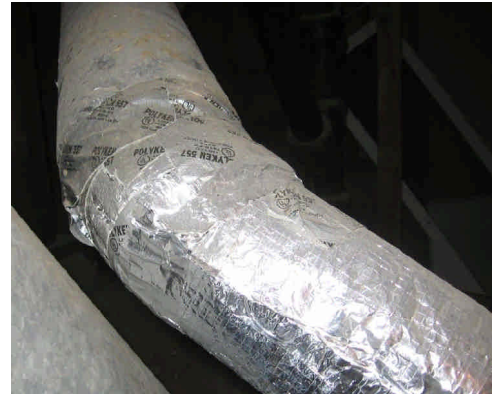
714 VENTING SYSTEM(S)

[SC] The vent was covered with insulation. This is a fire hazard. We recommend correcting the condition(s) noted.

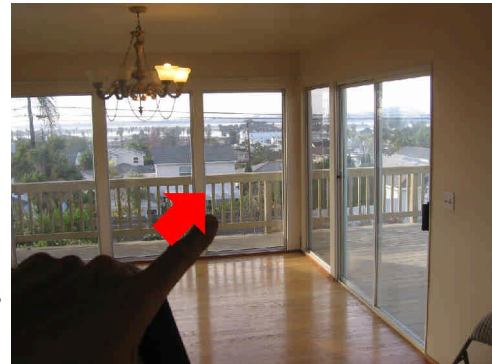
[SC] The frame was loose from the glass in living room, this condition is a potential safety hazard. We recommend correcting the condition(s) noted.

[SC] The sleeping room windows in this building may have met the building standards at the time of construction. However, the windows do not meet today's standards for emergency egress, due to one or both of the following conditions: The windows are too high above the floor [above the 44" rule], some of them are too small [less than the 5.7 sq. ft. rule]. Upgrading the windows to the present standards is not required, although we do recommend it. We feel it is important that the residents be aware of the conditions stated. Placing climbable furniture in front of windows may be beneficial for emergency egress should the need arise. We also recommend 2nd/3rd story bedrooms retain an Emergency Fire Escape Ladder for egress purposes.

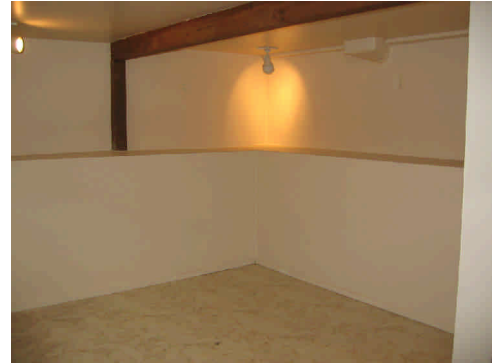
[SC] The under-stair fire protective barrier was compromised. We recommend correcting the condition(s) noted.

- 924 HANDRAIL(S) [SC] The handrail(s) were loose. We recommend correcting the condition(s) noted.
- [SC] The handrail(s) did not have "returns" to the wall to prevent the catching of clothing, bags, etc. We recommend correcting the condition(s) noted.
- 925 GUARDRAIL(S) [SC] There were no guardrails where needed at the additional room in the bottom floor. We recommend correcting the condition(s) noted.
- 926 COMMENTS:

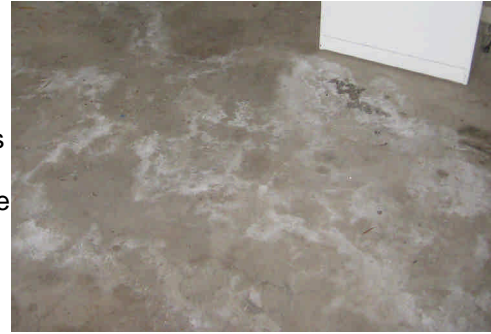
[SC] Evidence of ponding water was noted on the garage floor. This condition is a slip and fall hazard. We recommend correcting the condition(s) noted.

[CR] There was evidence of a moisture condition in the garage floor. We recommend locating and correcting the source as well as any damaged materials.
